HP ProLiant Gen8 Troubleshooting Guide

Volume II: Error Messages

Part Number: 658801-003
November 2013
Edition: 3

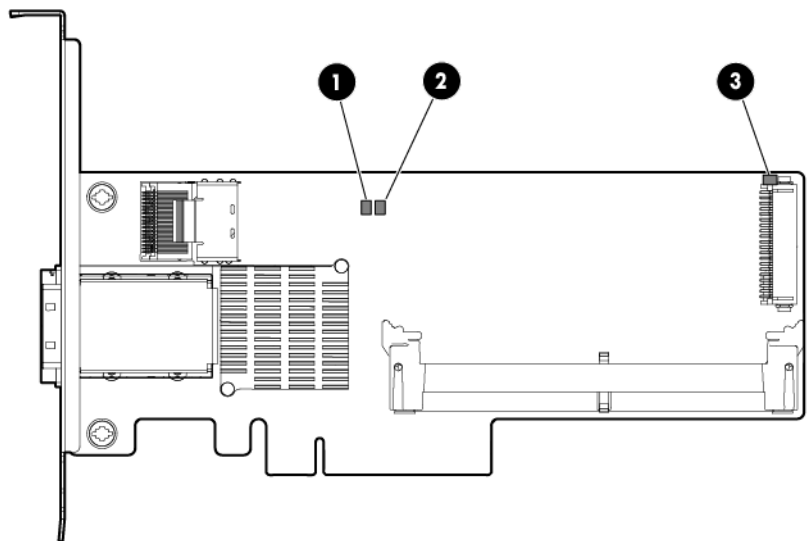
P222 LEDs

Item	Color	Name	Interpretation
1	Green	Heartbeat	When the controller is in good health, this LED flashes at 1 Hz. During power up, this LED is solid for up to 2 seconds.
2	Red	Fault	When an error occurs, this LED is on. During power up, this LED is solid for up to 2 seconds.
3	Amber	Debug	On = Controller is in reset. Off = Controller is in an idle or runtime state. Flashing 5 Hz = Controller and cache are performing a backup.

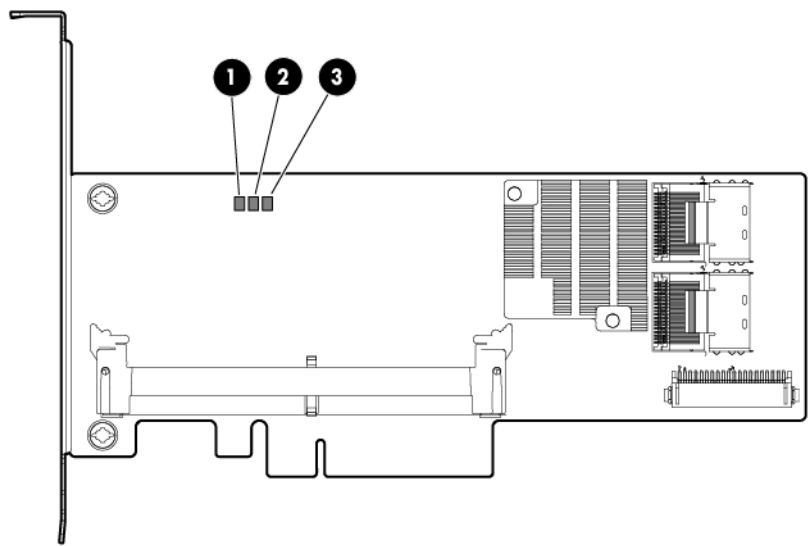
P420 LEDs

Item	Color	Name	Interpretation
1	Amber	Debug	On = Controller is in reset state. Off = Controller is in an idle or runtime state. Flashing 5 Hz = Controller and cache are performing a backup.
2	Red	Fault	When an error occurs, this LED is on. During power up, this LED is solid for up to 2 seconds.
3	Green	Heartbeat	When the controller is in good health, this LED flashes at 1 Hz. During power up, this LED is solid for up to 2 seconds.

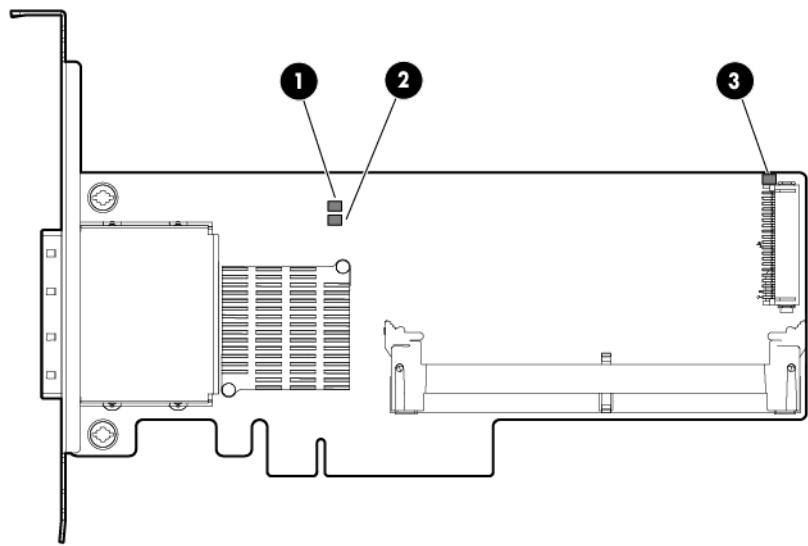
P421 LEDs

Item	Color	Name	Interpretation
1	Green	Heartbeat	When the controller is in good health, this LED flashes at 1 Hz.

Item	Color	Name	Interpretation
			During power up, this LED is solid for up to 2 seconds.
2	Red	Fault	When an error occurs, this LED is on. During power up, this LED is solid for up to 2 seconds.
3	Amber	Debug	On = Controller is in reset. Off = Controller is in an idle or runtime state. Flashing 5 Hz = Controller and cache are performing a backup.

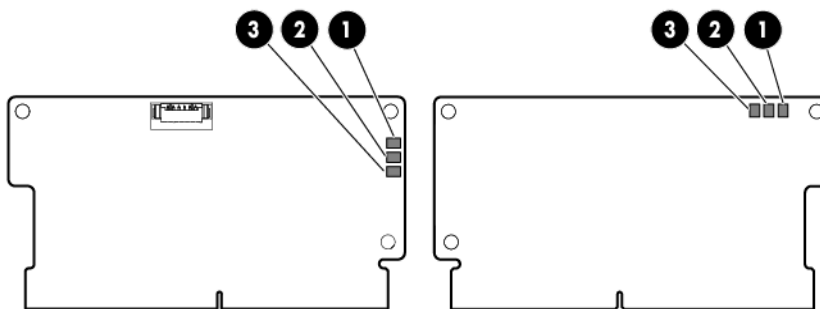
FBWC module LEDs (P222, P420, P421)

The FBWC module has three single-color LEDs (one amber and two green). The LEDs are duplicated on the reverse side of the cache module to facilitate status viewing.

1 - Amber	2 - Green	3 - Green	Interpretation
Off	Off	Off	The cache module is not powered.
Off	Flashing 0.5 Hz	Flashing 0.5 Hz	The cache microcontroller is executing from within its boot loader and receiving new flash code from the host controller.
Off	Flashing 1 Hz	Flashing 1 Hz	The cache module is powering up, and the capacitor pack is charging.
Off	Off	Flashing 1 Hz	The cache module is idle, and the capacitor pack is charging.
Off	Off	On	The cache module is idle, and the capacitor pack is charged.
Off	On	On	The cache module is idle, the capacitor pack is charged, and the cache contains data that has not yet been written to the drives.
Off	Flashing 1 Hz	Off	A backup is in progress.
Off	On	Off	The current backup is complete with no errors.
Flashing 1 Hz	Flashing 1 Hz	Off	The current backup failed, and data has been lost.
Flashing 1 Hz	Flashing 1 Hz	On	A power error occurred during the previous or current boot. Data may be corrupt.

Flashing 1 Hz	On	Off	An overtemperature condition exists.
Flashing 2 Hz	Flashing 2 Hz	Off	The capacitor pack is not attached.

1 - Amber	2 - Green	3 - Green	Interpretation
Flashing 2 Hz	Flashing 2 Hz	On	The capacitor has been charging for 10 minutes, but has not reached sufficient charge to perform a full backup.
On	On	Off	The current backup is complete, but power fluctuations occurred during the backup.
On	On	On	The cache module microcontroller has failed.

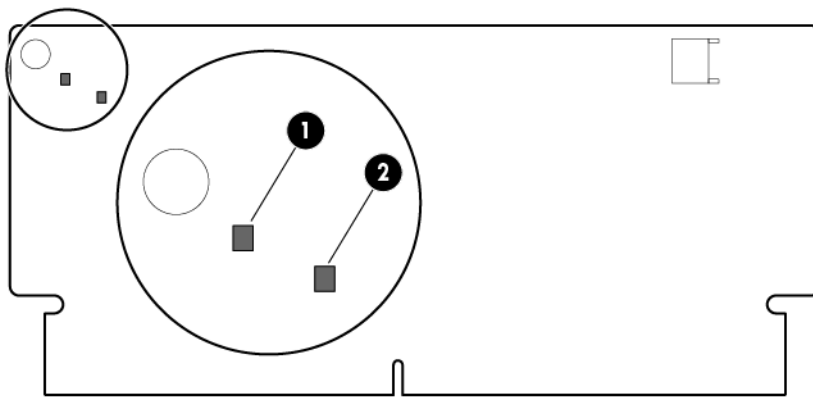
FBWC module LEDs (P410, P411, P711m, P812)

The FBWC module has two single-color LEDs (green and amber). The LEDs are duplicated on the reverse side of the cache module to facilitate status viewing.

1 Green LED	2 Amber LED	Interpretation
Off	On	A backup is in progress.
Flashing (1 Hz)	On	A restore is in progress.
Flashing (1 Hz)	Off	The capacitor pack is charging.
On	Off	The capacitor pack has completed charging.
Flashing (2 Hz) Alternating with amber LED	Flashing (2 Hz) Alternating with green LED	One of the following conditions exists: <ul style="list-style-type: none"> The charging process has timed out. The capacitor pack is not connected.
On	On	The flash code image failed to load.
Off	Off	The flash code is corrupt.

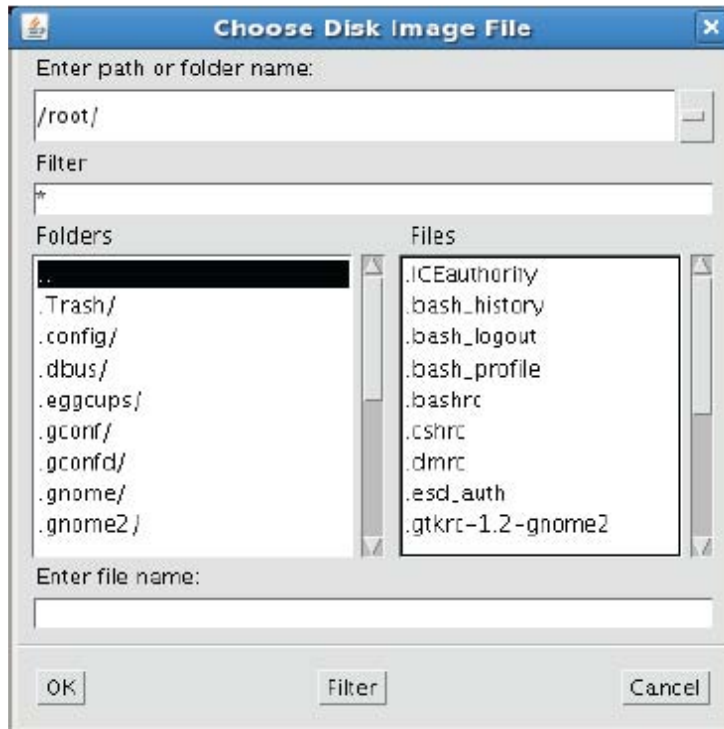
3. Log in to iLO using Firefox.
4. Insert a USB key or Floppy on the local client system. Ensure you can access them.
5. Open a Java IRC session.
6. Click **Virtual Drives>Floppy/USB-key**, and select Virtual Media. Verify the Linux box displays.

7. Type or select the path of the USB-key/floppy (**/dev/disk**) which is inserted to the client.
8. Click the **OK** button.

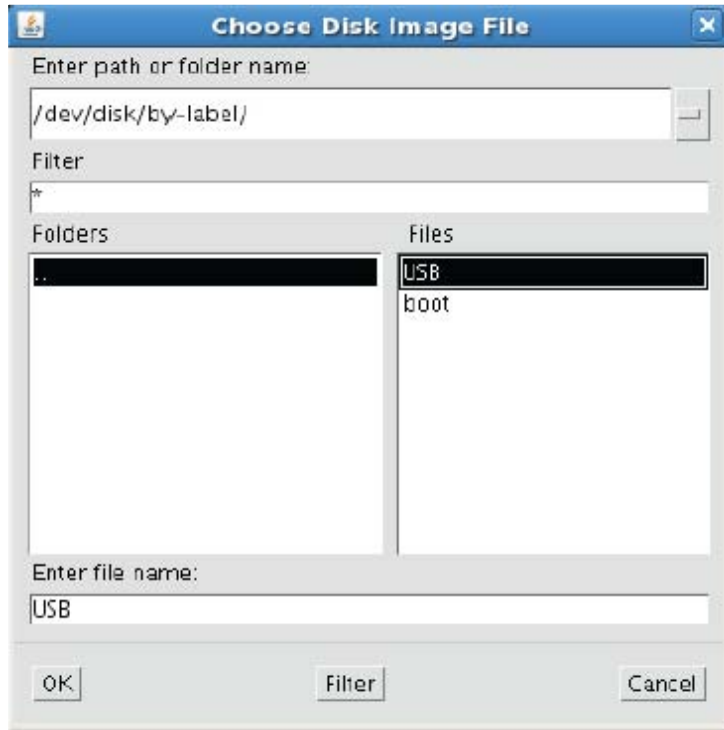
The image shows how to mount the USB key by-label.
